## CIVIL AERONAUTICS BOARD

## ACCIDENT INVESTIGATION REPORT

COMPANIA CUBANA DE AVIACION, S. A. AND U. S. NAVY,  
KEY WEST, FLORIDA, APRIL 25, 1951

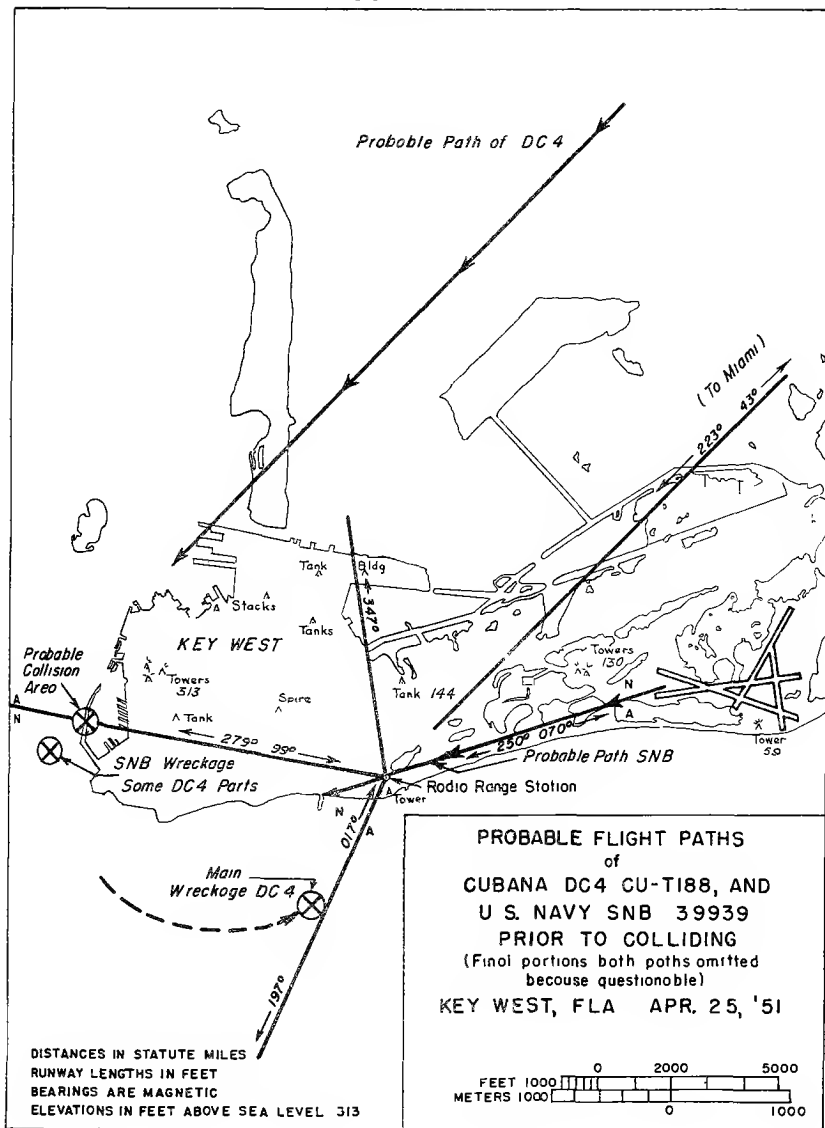
# Appendix I

On the morning of the same day a twin-engine Beechcraft, Navy designation SNB No. 39939, was scheduled for a simulated instrument training flight from the U. S. Naval Air Station,<sup>5</sup> Key West, Florida, at 1120. The flight, to be conducted under visual flight rules, had no altitude or area assignment other than that necessary to accomplish the training mission. One portion of the mission requires a flight inbound on the east leg of the Key West Radio Range on a heading of 250° M, at an air speed of 140 knots. Upon recognition of the cone, the pilot proceeds outbound on the west leg of the range on a heading of 279°, reduces speed to 105 knots, lowers the landing gear and descends to an altitude of 1,300 feet. A procedure turn is then made and the prescribed pattern followed for a simulated instrument approach to Boca Chica Airport (See Appendix I).

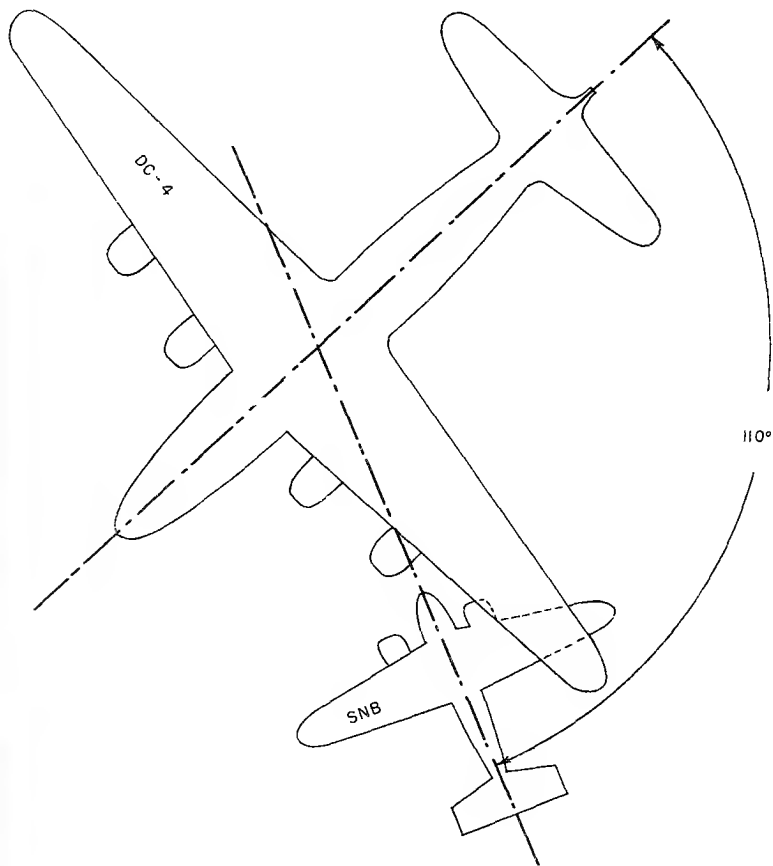
## Appendix II

Among the recovered portions of both aircraft, sufficient evidence was found to establish the position of the aircraft relative to each other at the moment of initial impact. The right propeller of the SNB had deep gouges on the leading edge of both blades. The section of the DC-4 left wing recovered with the SNB wreckage showed evidence of having been cut by a revolving object at wing stations 588 1/2 and 540 1/2, the cutting action being from the front to the rear of the wing and parallel to the longitudinal axis of the DC-4. The cut on the DC-4 left wing at station 588 1/2, which was made by one blade of the right propeller of the SNB, was the first contact between the two aircraft. The cut in the DC-4 left wing at station 540 1/2 by the second blade of the SNB right propeller, and the contact of the tip and leading edge of the DC-4 left wing with the

right side of the SNB fuselage, followed almost simultaneously. There was evidence of subsequent impact between the two aircraft, however, the damage was of such a nature that it was not possible to determine any sequence of events. The SNB propeller cuts in the DC-4 left wing indicated that the angle between the longitudinal axis of the two aircraft at the moment of impact was approximately  $110^{\circ}$  (See Appendix II).

ANGLE OF COLLISION AS DETERMINED BY EXAMINATION OF WRECKAGE  
CUBANA DC-4 CU-T188 AND U S NAVY SNB 39939  
KEY WEST, FLA APR 25, '51
